LARGE DIAMETER SPHERES

ARDEFORM PROCESS

Prepared under NASA Manned Spacecraft Center
Contract NAS 9-2648

FINAL REPORT

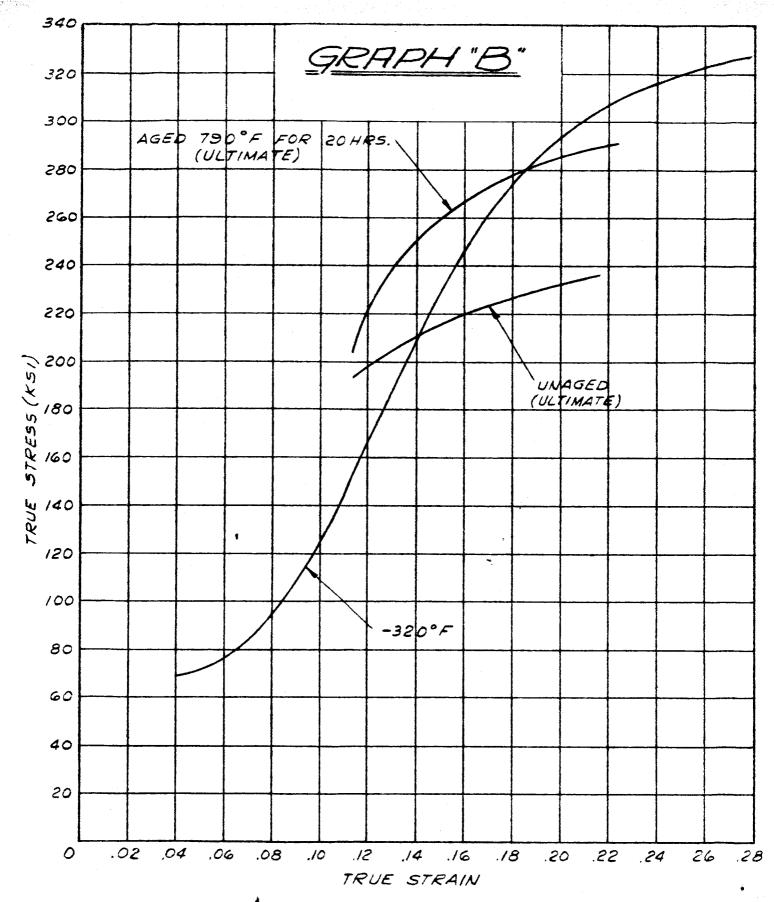
UNIAXIAL
TENSILE PROPERTIES
OF HEAT # E-73597

The engineering analysis for this design was based on prior experience with smaller diameter spheres. In particular, four spheres having a preform diameter of 6.95" were studied. These spheres were fabricated from AlS1 301 material, heat number E-73413 purchased from Eastern Stainless Steel. The results of cryoginially stretching and hydrostatic testing of these spheres are shown on Graph A as triangles. These practical results indicated a ± .006 inches per inch strain tolerance on the theoretical curve as shown on the graph.

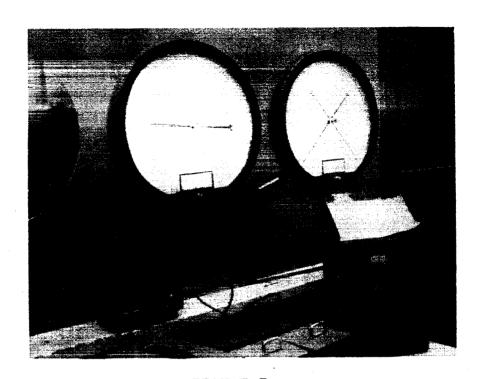
FIGURE 7
TEST EQUIPMENT SET-UP SHOWING HYDROTEST
PRESSURE GAGE AND STRAIN GAGE INSTRUMENTATION

Each completed sphere was subjected to a proof pressure test as shown in Figures 7 and 8. The target proof pressure was 1350 psig. In addition, each sphere was instrumented with two strain gages near the girth weld, one perpendicular to the weld, the other parallel to it. Results of strain gage data are shown in Figures 10 to 16A. One sphere was taken to burst. The resulting burst pressure was 1560 psig. as compared to the design burst pressure of 1508 psig.

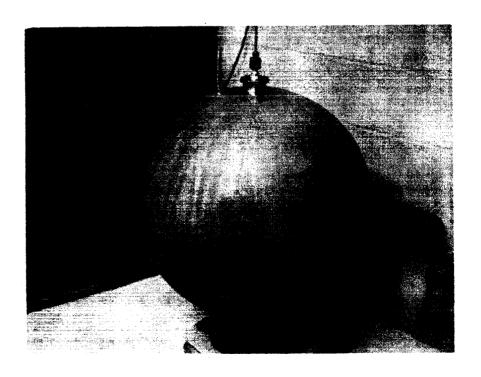
FIGURE 8
25" SPHERE-UNDERGOING PROOF PRESSURE CHECK

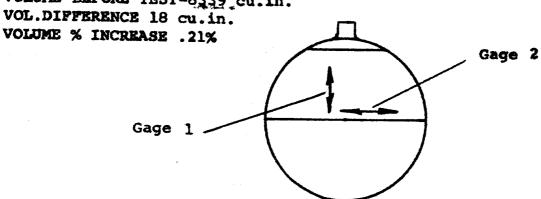
WEIGHT - 23 lbs.

VOLUME AFTER PRESSURE TEST - 8357 cu. in. VOLUME BEFORE TEST-8339 cu.in.

PRESSURE		Gage	Gage 2
		MICROINCH RE	ADINGS
0		10970	9800
300		11890	10690
500 ———	white the same of	12500	11320
		13120	
900		13770 ——	12650
1000 ———		14050	12970
1200 ———	· · · · · · · · · · · · · · · · · · ·	14710	13720
*1350		15180	14300

#### \* HELD FOR 3 MINUTES

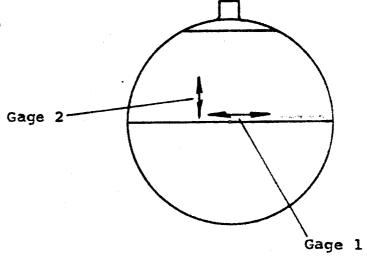
DIFFERENCE - 6 cu. in.

% INCREASE - .07%

PRESSURE	Gage l	Gage 2
	MICROINCH RE	<b>A</b> DINGS
0	12300	10500
500	- EXERCISE	GAGES -
0	12320	10490
300 ———	12900 —	11350
500	13350 ———	11990
*700	13760 ———	12550
<b>*</b> 900 ———	14240	13180
•1000	14400	13480
*1200	14850	14150
*1350	15150	14640

<sup>\*</sup> BOTH GAGES DROPPING - READINGS INCONCLUSIVE

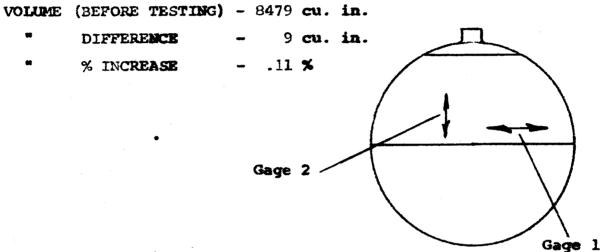
WEIGHT - 21.92 lbs.

VOLUME (AFTER TESTING) - 8488 cu. in.

PRESSURE	Gage 1	Gage 2
	MICROINCH I	
0	10840	10680
300	12020	11860
500	12840	12650
700	13700	13470
900	14670 <del></del>	14360
1000	15130	14790
1100	15630	15230
1200	16110	15690
*1350	16850	16360

\*HELD FOR 5 MINUTES - NO PRESSURE LOSS

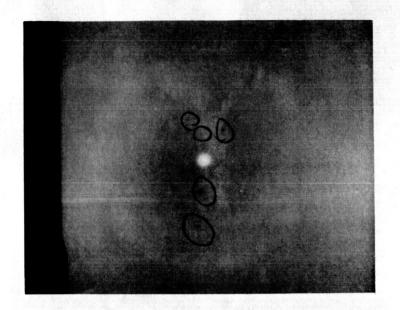
FIGURE 17

RADIOGRAPH OF S/N 1007

HEAD AT THE POLE AREA

(2) Voids and porosity due to the spinning operation occurred at the polar region. The first problem was eliminated by machining off less material per cut. Upon investigation it was determined that the voids at the polar region were in an area that would be removed in order to weld the bosses and, therefore, would not be detrimental to the finished vessel. Photographs from the metallurgical report are shown in Figures 17 through 19.

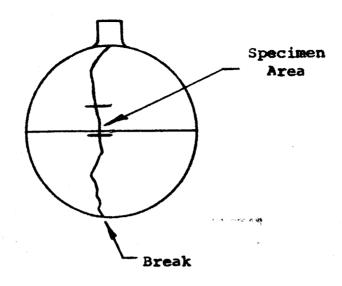
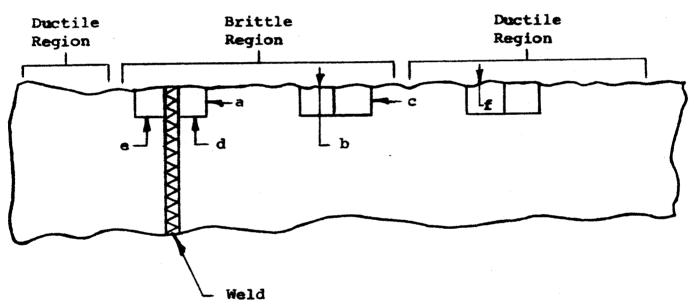
METALLURGICAL SPECIMEN LOCATION

The metallographic examination, which revealed information pertinent to the causes of failure in the sphere, is discussed below. The location and orientation of the metallographic specimens is shown in Figure 20. In the discussion below, locations and directions refer to those shown in Figure 20.

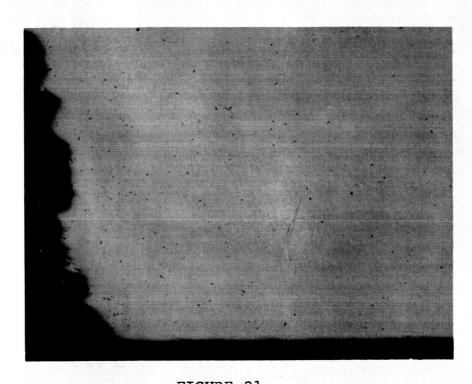
FIGURE 21
METALLOGRAPH SHOWING INCLUSIONS 100X

The inclusions in the material taken from the brittle fracture region show an orientation parallel to the path of the fracture. Figure 21 shows a view at c, in which the inclusions appear as small dots. Figure 22 shows a view at "b" in which slight elongation of the inclusions is apparent. Although this material can certainly not be characterized as a clean material, it does not appear that the inclusions were the primary cause of failure of the vessel. No drastic differences in appearances and quantity of inclusion were observed between those in the shear fracture region, the brittle fracture region and the weld area.

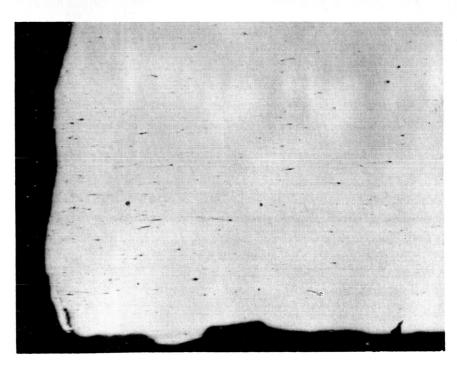
FIGURE 22

METTALLOGRAPH SHOWING INCLUSION ELONGATION 100X

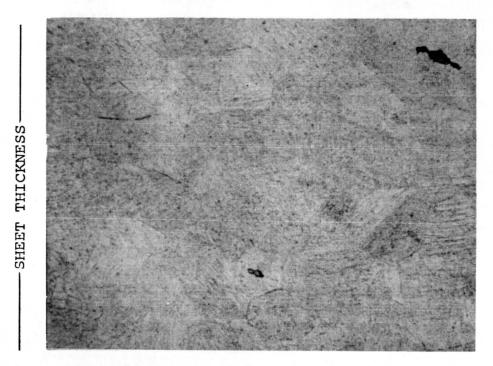
FIGURE 23

GRAIN STRUCTURE - TENSILE SPECIMEN - 17% CRYOGENIC STRETCH - LONGITUDINAL DIRECTION 540X

Transformation of the austenite to martensite occurs during the cryogenic stretch forming process. In order to determine the causes of failure it is valuable to investigate the material for conditions which existed prior to transformation. During the stretching of annealed material with equiaxed austenite grains, it has been observed that original austenite grain boundaries retain their equiaxed form. For example, Figures 23 and 24 are photomicrographs of the structure of a tensile specimen cryogenically stretched about 17%. These photographs, show the structure in the transverse and longitudinal directions. The similarity of the two photographs indicates that structural isotropy is retained even for large plastic deformations by stretching.

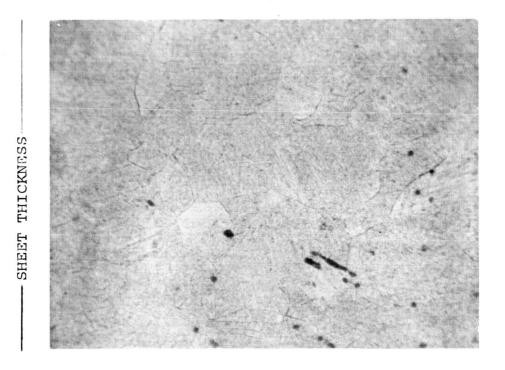
FIGURE 24

GRAIN STRUCTURE - TENSILE SPECIMEN -17% CRYOGENIC STRETCH - TRANSVERSE DIRECTION 540X

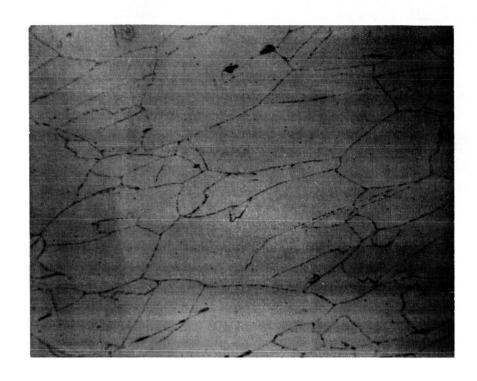
FIGURE 25

GRAIN STRUCTURE ELONGATED

PARALLEL TO THE FRACTURE 540X

Examination of the metallographic specimens from the sphere, however, indicates definite structural anisotropy in the region of brittle fracture. Figures 25 and 26 are photomicrographs with the line of sight parallel and perpendicular to the fracture direction, respectively. Figure 25 shows view "d" and Figure 26 shows view "a" as indicated in Figure 20. Note that in Figure 25 that the grain structure is elongated parallel to the fracture. A view at "b", showing elongated grains and at "c" showing the equiaxed ends of these grains is shown in Figures 27 and 28, respectively. The grain elongation parallel to the fracture is evident only in locations near the brittle fracture region. A view at "f" Figure 29, shows essentially equiaxed grains, in the vicinity of the ductile fractures. Figure 29 should be compared with a view "d" in Figure 30 at the same magnification.

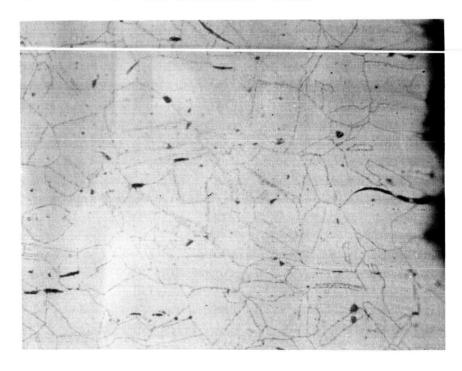
FIGURE 26

GRAIN STRUCTURE PERPENDICULAR TO FRACTURE DIRECTION 540X

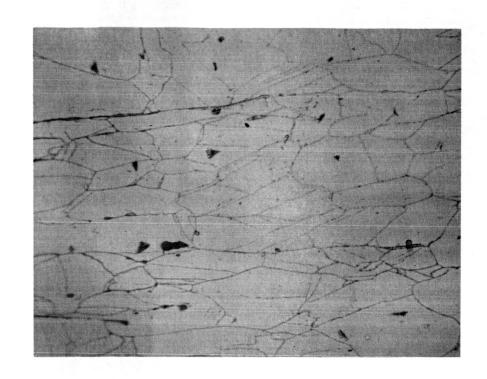
FIGURE 27

GRAIN STRUCTURE SHOWING ELONGATED GRAIN 540X

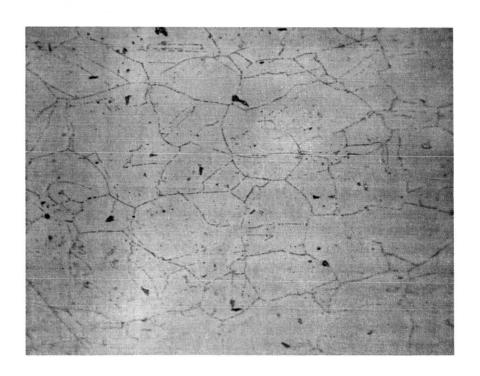
FIGURE 28

END GRAIN STRUCTURE OF GRAINS SHOWN IN FIGURE 8
540X

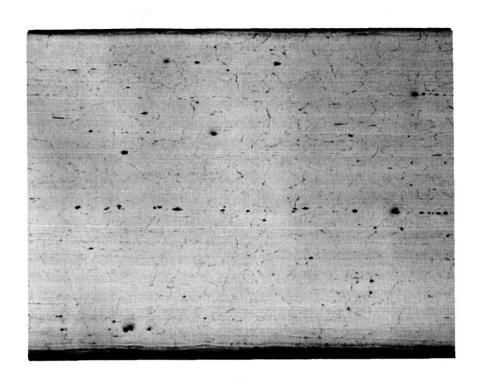
FIGURE 29

EQUIAXED GRAIN STRUCTURE IN
REGION OF DUCTILE FAILURE 100X

Some carbide precipitation was noted in the prior austenite grain boundaries at all locations. The greatest amount of carbide precipitation, however, was noted at view "d", near the weld. Although some precipitation is to be expected in the vicinity of the weld, the extent of precipitation far exceeded that ordinarily noted. By comparison, the precipitation noted at location "e" at the beginning of the weld carbide zone on the other side of the weld, was very slight. In fact, precipitation at locations "b" and "c", removed from the weld, but near the brittle fracture region, were more extensive than that noted in the carbide zone at "e". View "f", Figure 29 at the ductile fracture region shows only a small amount of precipitation.

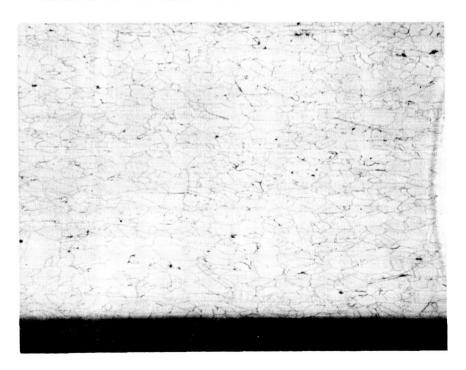
FIGURE 30

ELONGATED GRAIN STRUCTURE IN REGION OF BRITTLE FAILURE 100X

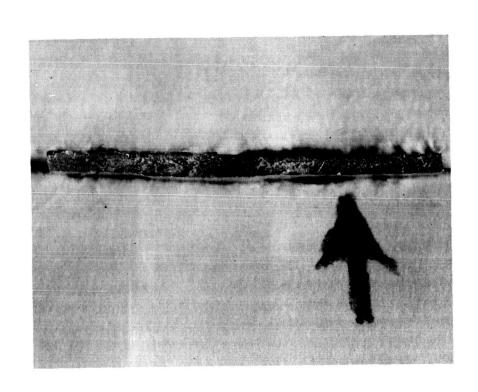
FIGURE 31

FRACTURE SURFACE AT SUSPECTED

ORIGIN OF FAILURE 5X

Anneal heads after machining or after welding. A proper anneal and quench is more readily controlled in the thinner material. The precise location of failure was difficult to pin point because of some rubbing of the fracture surface during shipment of the failed vessel to the laboratory. A photograph of the fracture surface at the suspected failure

origin is shown in Figure 31. The origin appears to be in the "carbide zone" on the bad side of the weld. This is not unreasonable under the circumstances since the carbides precipitated during welding merely increased the amount already present as a result of improper annealing and quenching.
